UT-058-45N

Inspection Date: 7/6/90

Inspector: Linda L. Jackson

Claim: Grant #1 & #2  
(UMC 263241-263242)

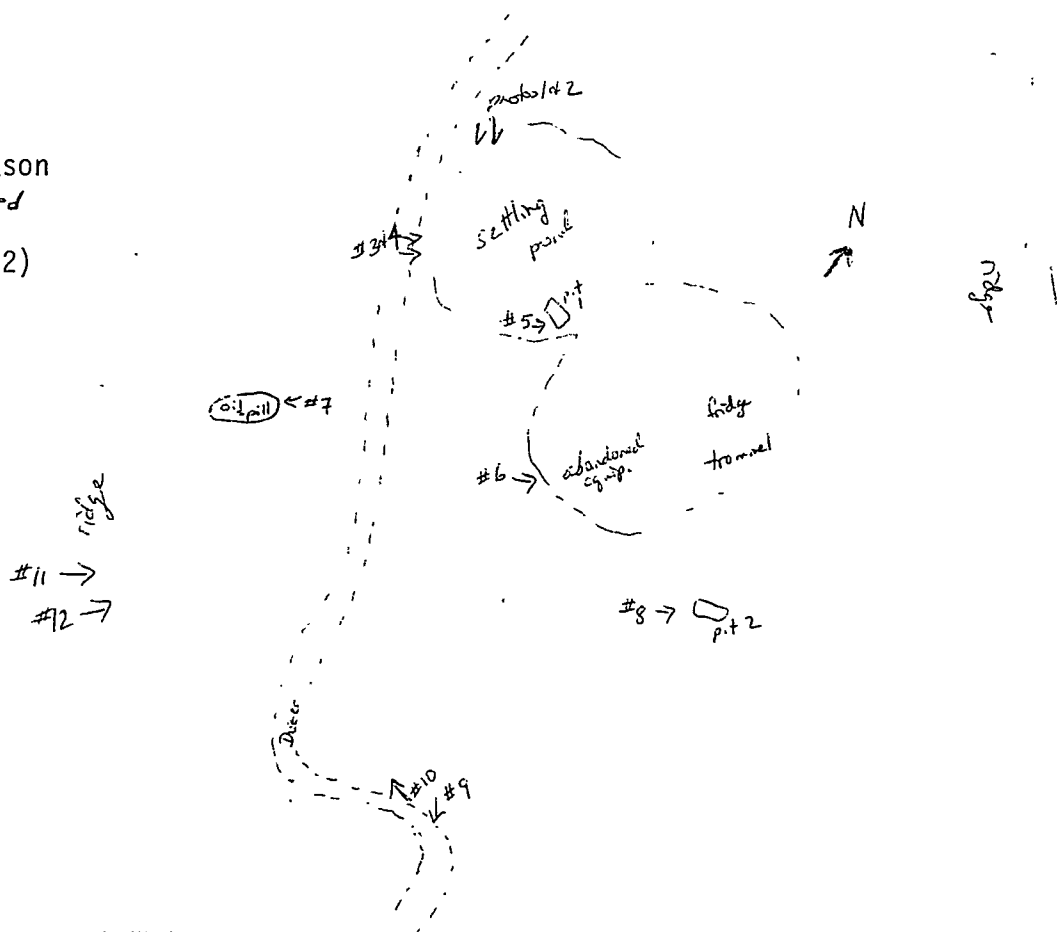
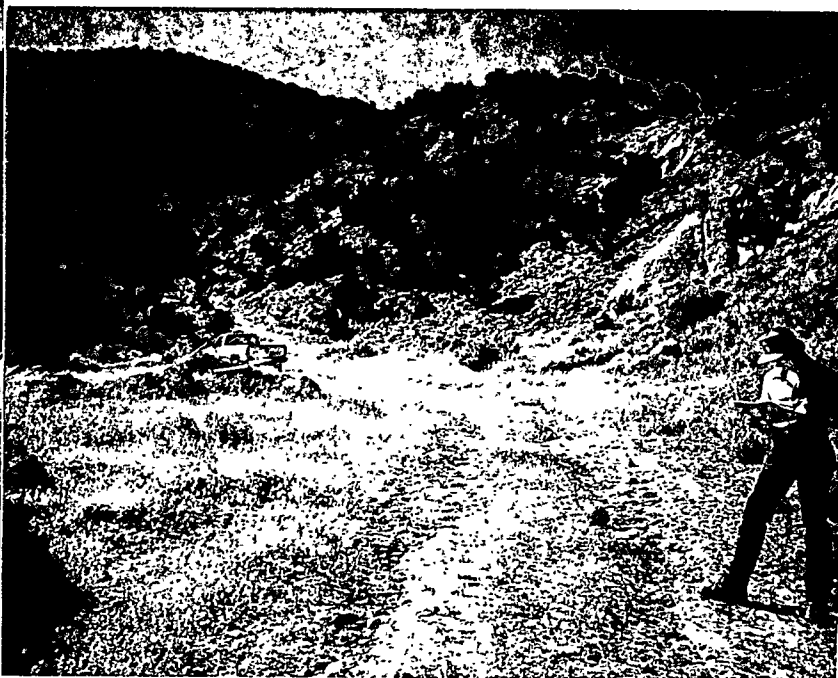
Photo 1 & 2. Photo taken from north end of disturbed area.  
T. 21 S., R. 1 E., Section 15, NW1/4NW1/4.

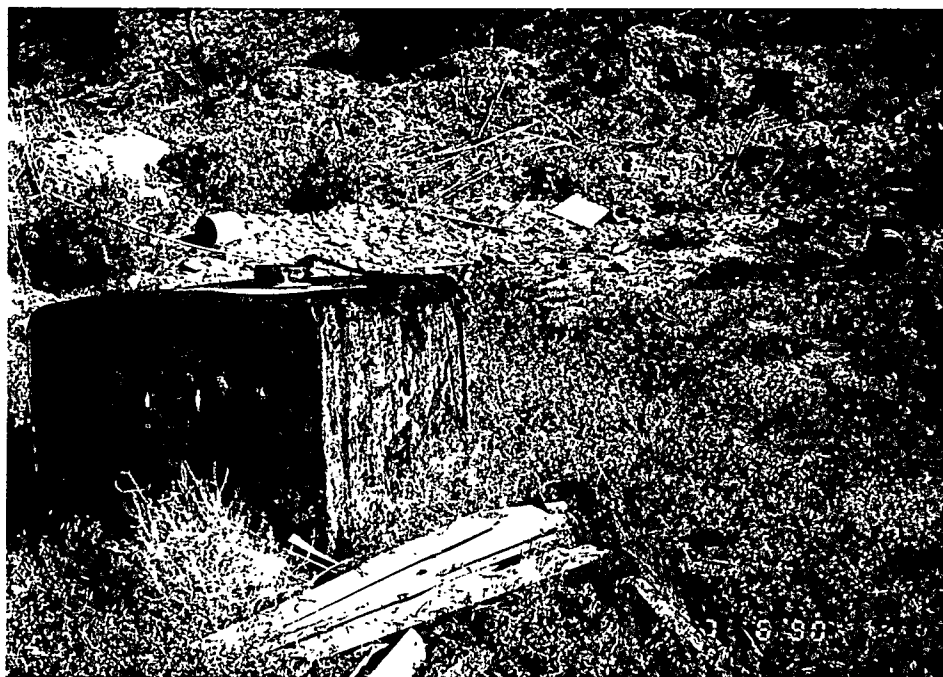
Photo 4. Discarded equipment and trash -- boards, glass, cans, old fence

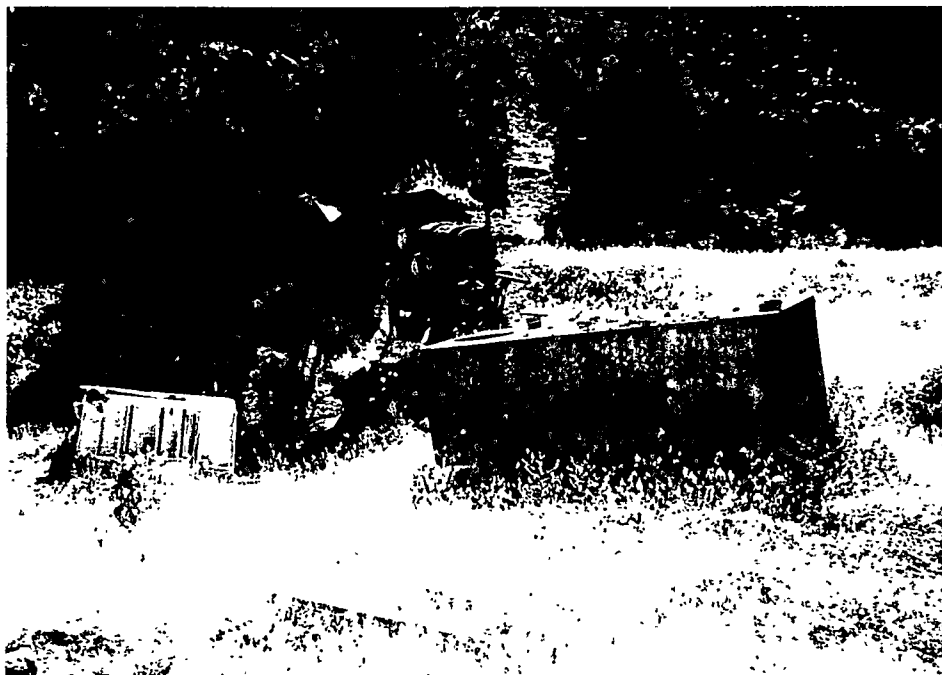
Photo 6. Trommel and discarded equipment.

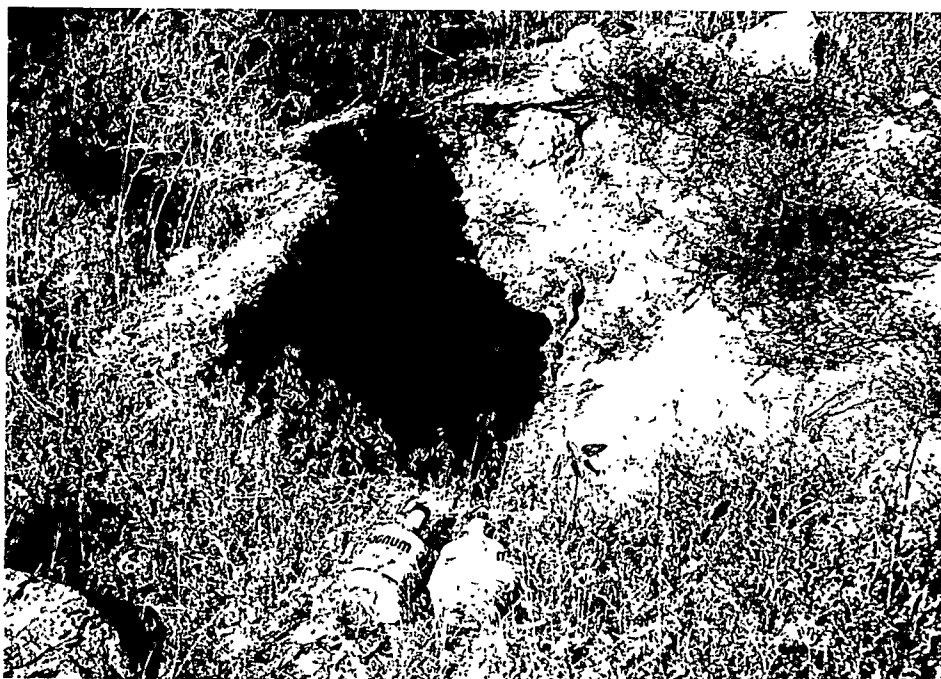
Photo 8. Pit, 4 ft long X 2 ft wide X 2 ft deep.

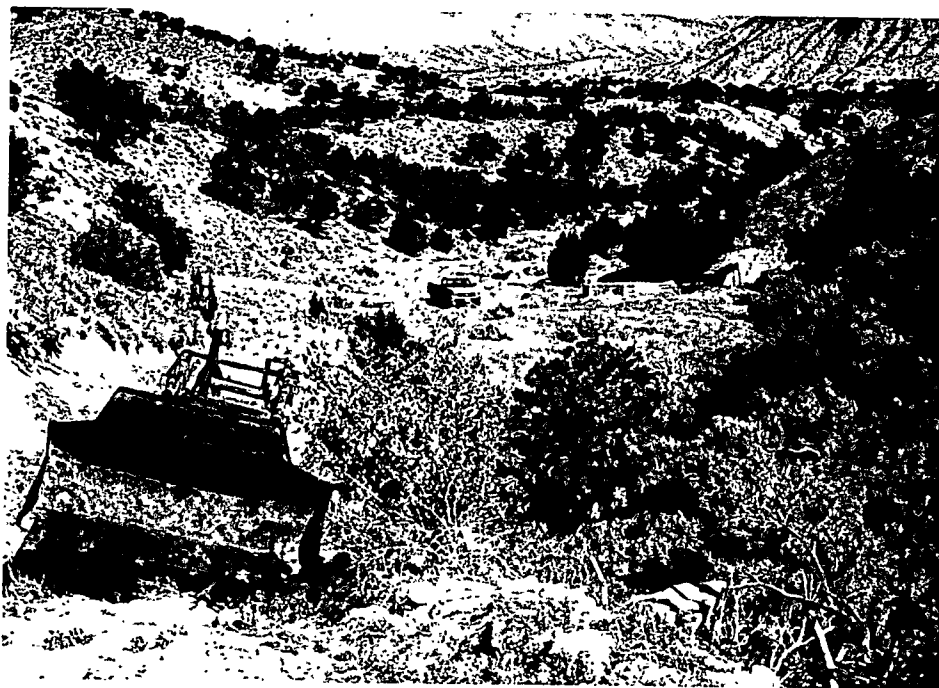
Photo 10. View to the NW. Constructed road and dozer.

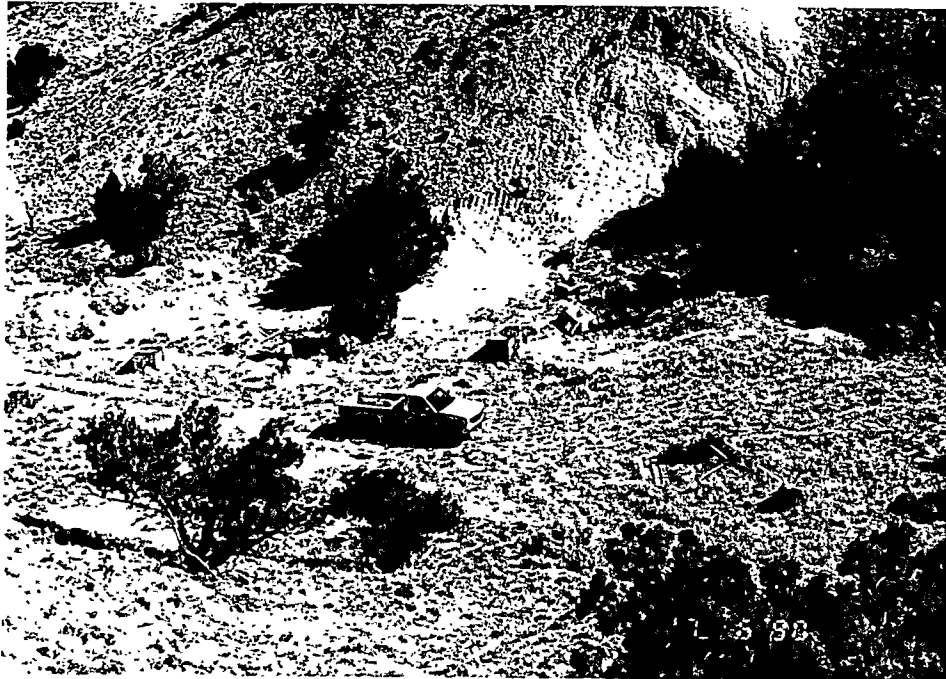
Photo 11. General view of disturbed area. Settling pond to center left. Debris scattered throughout area.

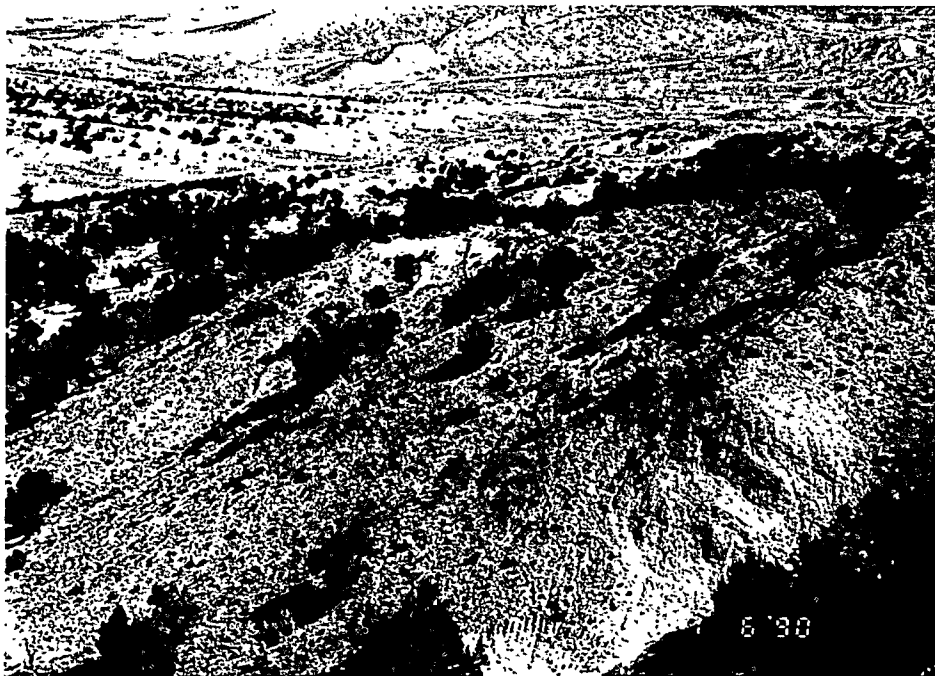
Photo 12. View to the NW. Photo of ridge on north side of disturbed area. Note open cut 30 ft X 80 ft. Source of clay liner material.
